Job Name: 24-4112 - Ohio River Service Area Rehab  
 Job Location: Louisville, KY 40222  
 Contractor: TRC, LLC

**Structure ID: Cardinal Harbour Wet Well**

**P4 MH072RSVF**

**MH RISER Custom Ht T/G**

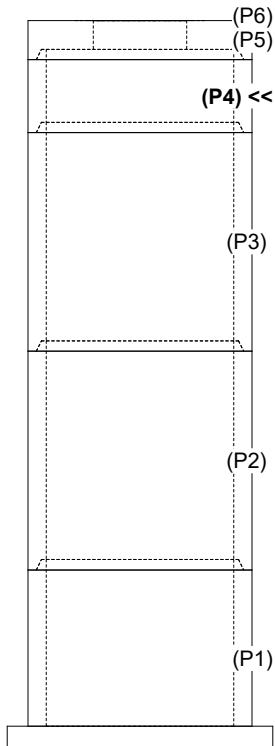
**RIGHT-SIDE UP VIEW (int. dimensions)**

**INSIDE WALL DIMENSIONS**

Seam Up: Tongue  
 Seam Dn: Groove

Wall Thickness: 7"  
 Floor Height: 0"

Height (Int): 28"  
 Height (Ext): 28"

Weight (Net): 4082 lb  
 Volume (Net): 1.04cu.yd
